NISTIR 5645

Evaluation of Thermal Wave Imaging for Detection of Machining Damage in Ceramics

**L. Wei
H.H.K. Xu
S. Jahanmir**

March 1995

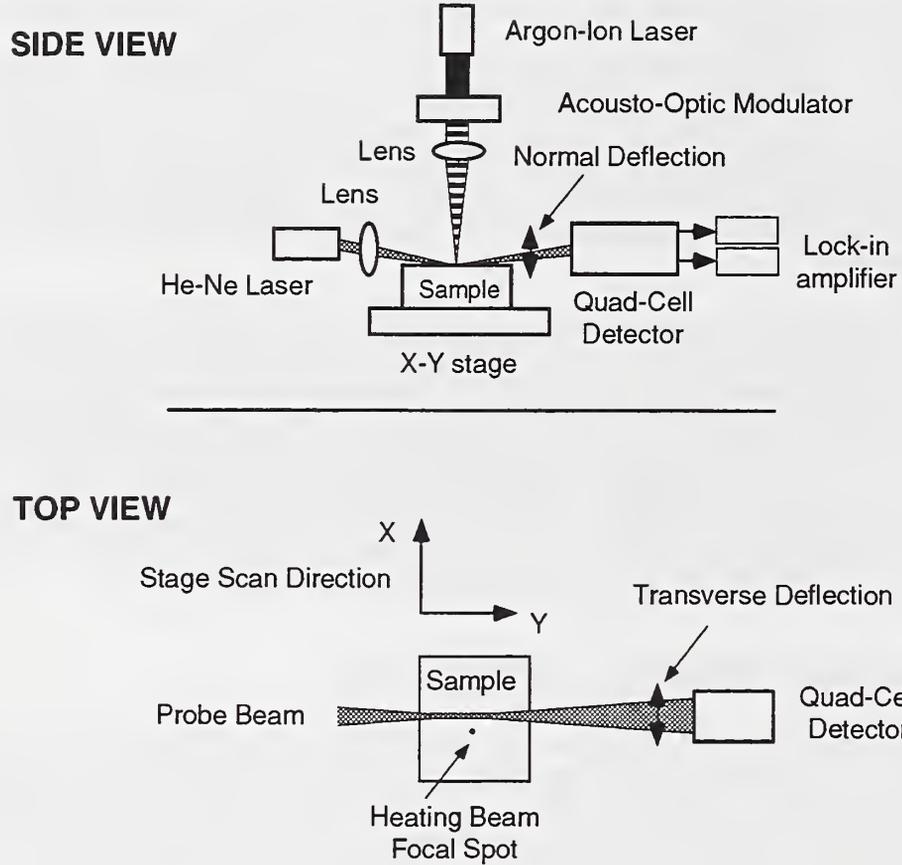
Figure 1. Schematic diagram of the thermal wave measurement system with the optical beam deflection technique [16].

A schematic diagram of the experimental setup is shown in Fig.1. An argon-ion laser beam is chopped by an acousto-optic modulator and is focused on the sample surface to provide a periodic localized heat source. The He-Ne laser probe beam bounces at a near grazing angle from the surface of the heating area; and it is refracted by the time varying gradient in the index of refraction

of the air caused by the temperature gradient. The vector deflection of the probe beam is measured by a position-sensitive, quad-cell detector, the output voltages of which are amplified and fed into two separate vector lock-in amplifiers: one to monitor the component normal to the surface (i.e., the normal deflection), and the other to monitor the deflection parallel to the surface (i.e., the transverse deflection).

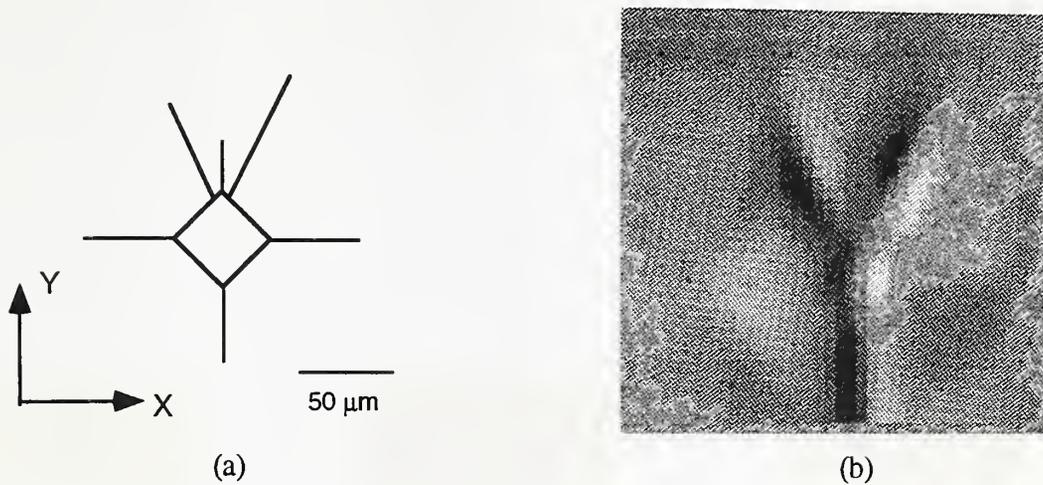
Figure 2. (a) Schematic drawing of the indentation mark on soda-lime glass, and (b) thermal wave image of the indentation mark using the transverse deflection component of the probe beam. (The scan area is $200\ \mu\text{m} \times 200\ \mu\text{m}$ with a step size of $5\ \mu\text{m}$ in both x and y directions).

Figure 2a shows the impression made on the glass specimen under an indentation load of 9.8 N. The median/radial cracks emanating from the corners of the indent are also shown. The thermal wave image using the transverse deflection component is shown in Fig. 2b. The transverse deflection component of the probe beam was used for the detection of the median/radial cracks because the transverse deflection component is more sensitive to the thermal waves with preferential propagation along the surface and perpendicular to the vertical crack plane [7]. In the image shown in Fig. 2b, the median/radial cracks appear darker than the background because of local temperature rise due to the reflection of thermal waves from the cracks. The Y-shape of the median/radial cracks can be clearly seen, while the lateral cracks and the depression of the indent are only vaguely seen in the background. It is important to note that the cracks along the x-direction are located in a plane parallel to the heat propagation direction and do not disturb the heat flow; therefore, these cracks are not detected in the thermal wave image of Fig. 2b.

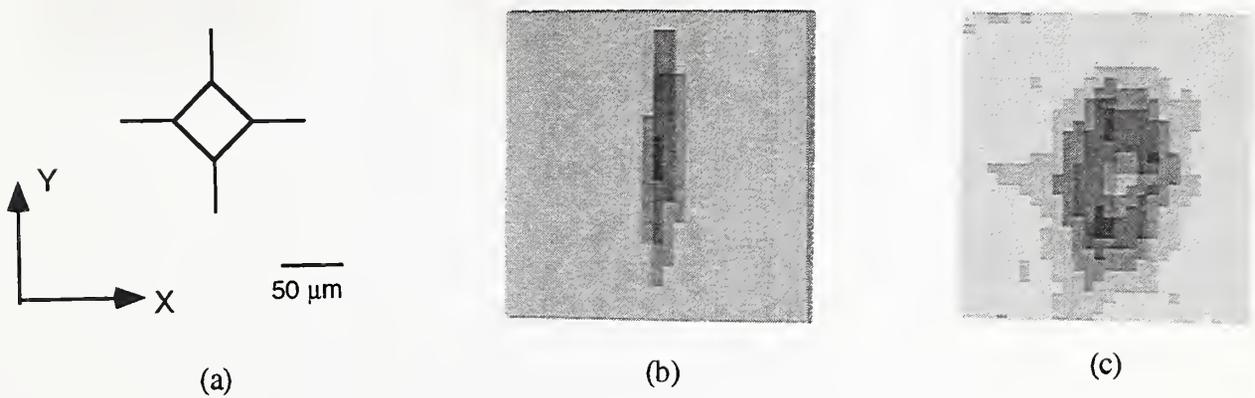
Figure 3. (a) Schematic drawing of the indentation mark on silicon nitride, (b) thermal wave image of the indentation mark using the transverse deflection component of the probe beam, and (c) thermal wave image of the same area using the normal deflection component. (The scan area for both images in (b) and (c) is $300\ \mu\text{m} \times 300\ \mu\text{m}$ with a step size of $10\ \mu\text{m}$ in both x and y directions).

Figure 3a is a schematic drawing of the indentation mark made at a load of 98 N in the silicon nitride specimen. Both the impression and the well-developed median/radial cracks are shown. Figure 3b and 3c are the corresponding thermal wave images using the transverse and the normal components of the deflected probe beam, respectively. Similar to the results obtained for the glass specimen, the thermal wave image in Fig. 3b shows only the median/radial cracks located in the y-direction. Figure 3c, on the other hand, shows the lateral cracks only, because the normal deflection component is more sensitive to the cracks that are parallel to the surface.

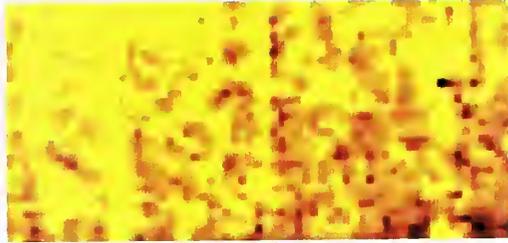
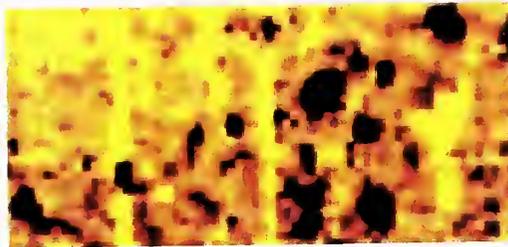
Figure 5. Thermal wave images of the ground surface of alumina with an average grain size of 35 μm examined at a modulation frequency of (a) 50 kHz and (b) 500 Hz using the normal component of the deflected probe beam. The scan area of each image is 500 μm x 250 μm .

- (3) Different modulation frequencies were used to vary the penetration depth of the thermal waves. The thermal wave images in Figs. 5a and 5b were obtained at two different frequencies of 50 kHz and 500 Hz. The two thermal wave images correspond to penetration depths of $\approx 10 \mu\text{m}$ and $\approx 100 \mu\text{m}$, respectively from the same area on the ground surface of the alumina with an average grain size of 35 μm . Only a few high-temperature regions are observed in the thermal wave image which corresponds to a penetration depth of $\approx 10 \mu\text{m}$ (Fig. 5a). In contrast with this observation, several dark spots are seen in Fig. 5b obtained from a penetration depth of $\approx 100 \mu\text{m}$. The comparison between the two images implies that the high-temperature regions in Fig. 5b are associated with subsurface damage

located at a depth between 10 and 100 μm .

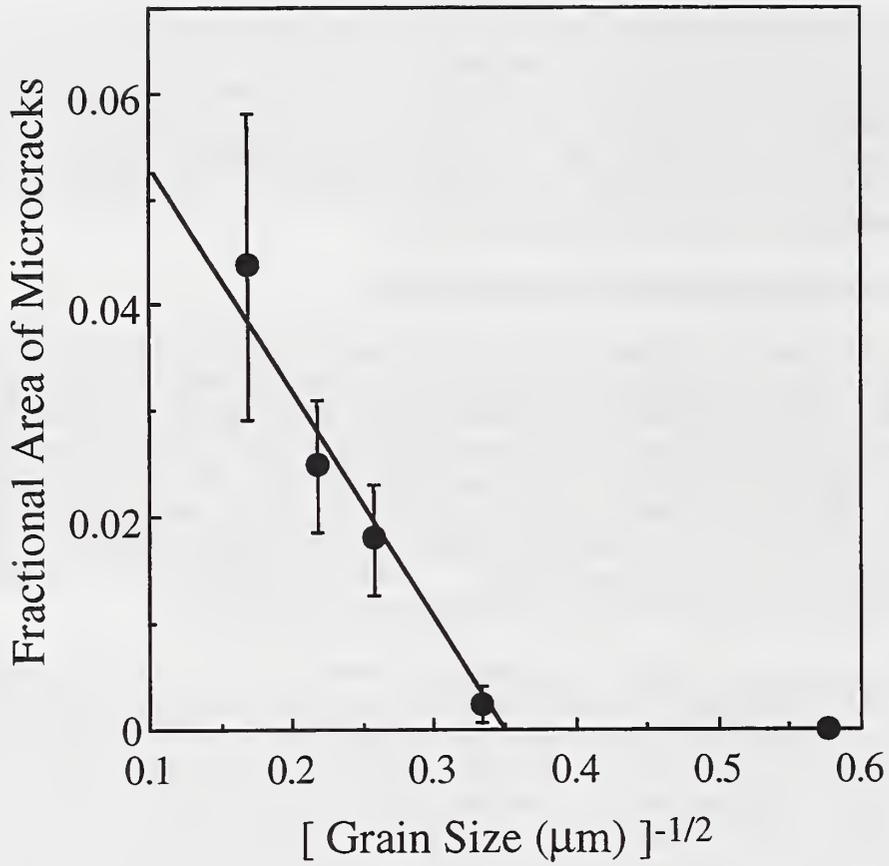
Figure 6. Fractional area of subsurface microcracks (or microcrack density) in ground alumina, measured by thermal wave imaging, plotted versus the inverse square root of the grain size. Each data point is the average of four measurements and the error bars are the standard deviation of the measurements.

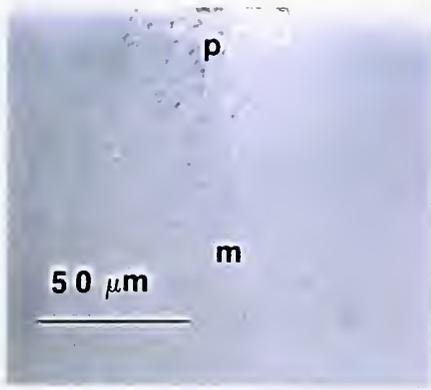
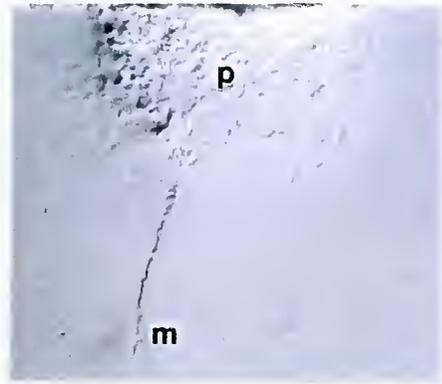
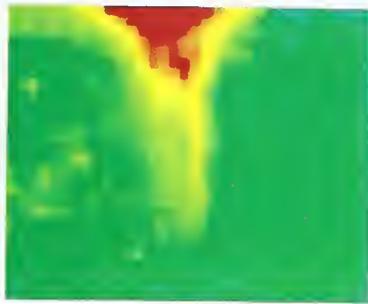
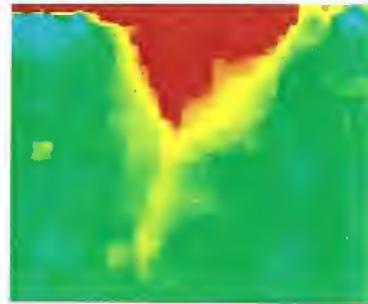
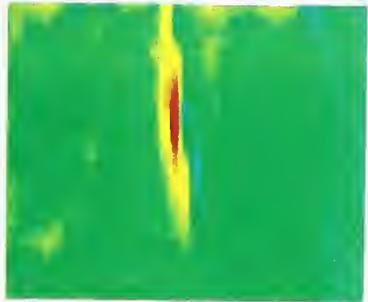
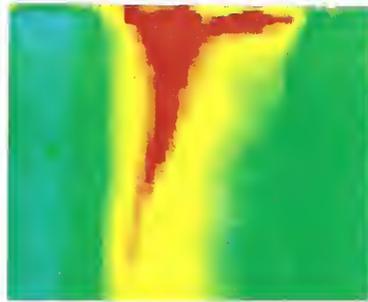
Figure 7. (a) and (b) are optical micrographs of the damage zone generated by scratching in a fine-grain silicon nitride and a coarse-grain silicon nitride; (c) and (d) are the thermal wave images using the normal deflection component of the probe beam; and (e) and (f) are the thermal wave images using the transverse deflection component of the probe beam. (The scan area for the thermal wave images is $160\ \mu\text{m} \times 170\ \mu\text{m}$).

The subsurface damage generated by scratching are observed in the optical micrographs of the sections in Figs. 7a and 7b. Figures 7c and 7d show the thermal wave images of the sections using the normal deflection component of the probe beam, while Figs. 7e and 7f are the thermal wave images using the transverse component. Note the correspondence between these thermal wave images and the optical micrographs. The median cracks (designated by "m") are more clear in Figs. 7e and 7f than in Figs. 7b and 7c because the transverse deflection component is more sensitive to vertical cracks. On the other hand, Figs. 7c and 7d show strong signals from the damage zone. We have shown in a previous publication that the damage zone associated with scratching contains numerous intergranular microcracks with different orientations [14]. Therefore, the thermal wave images obtained from the normal deflection component reflects the integrated effect of the microcracks distributed within the damage zone.

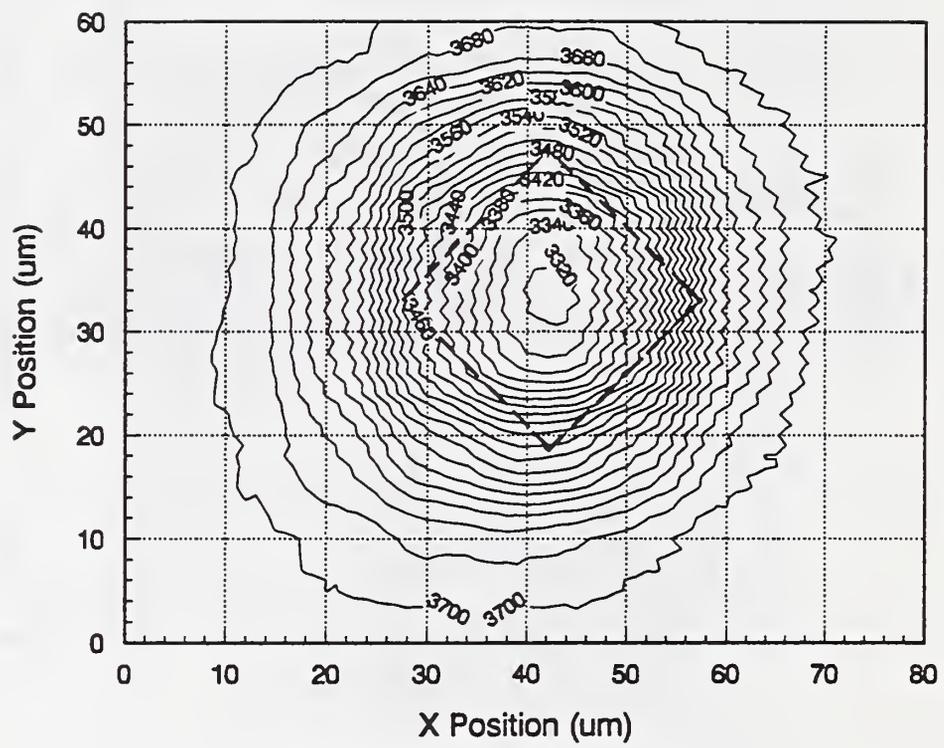
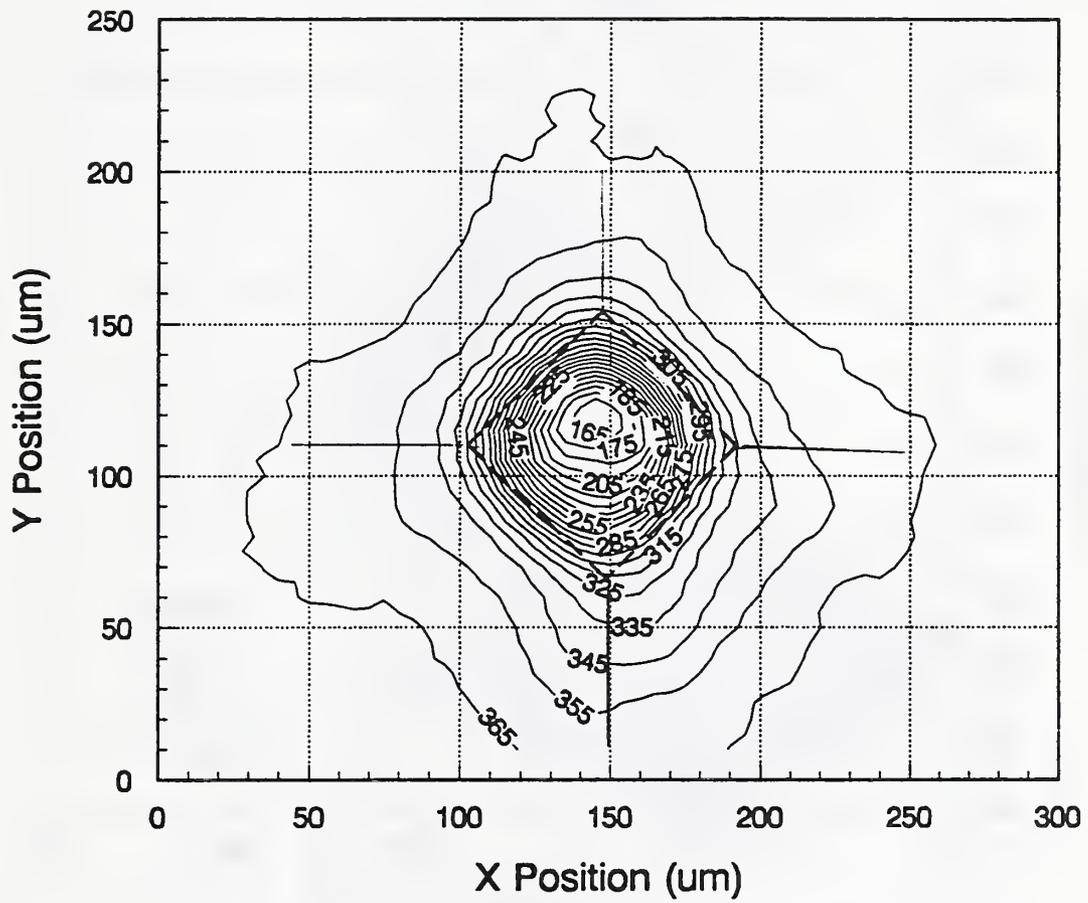
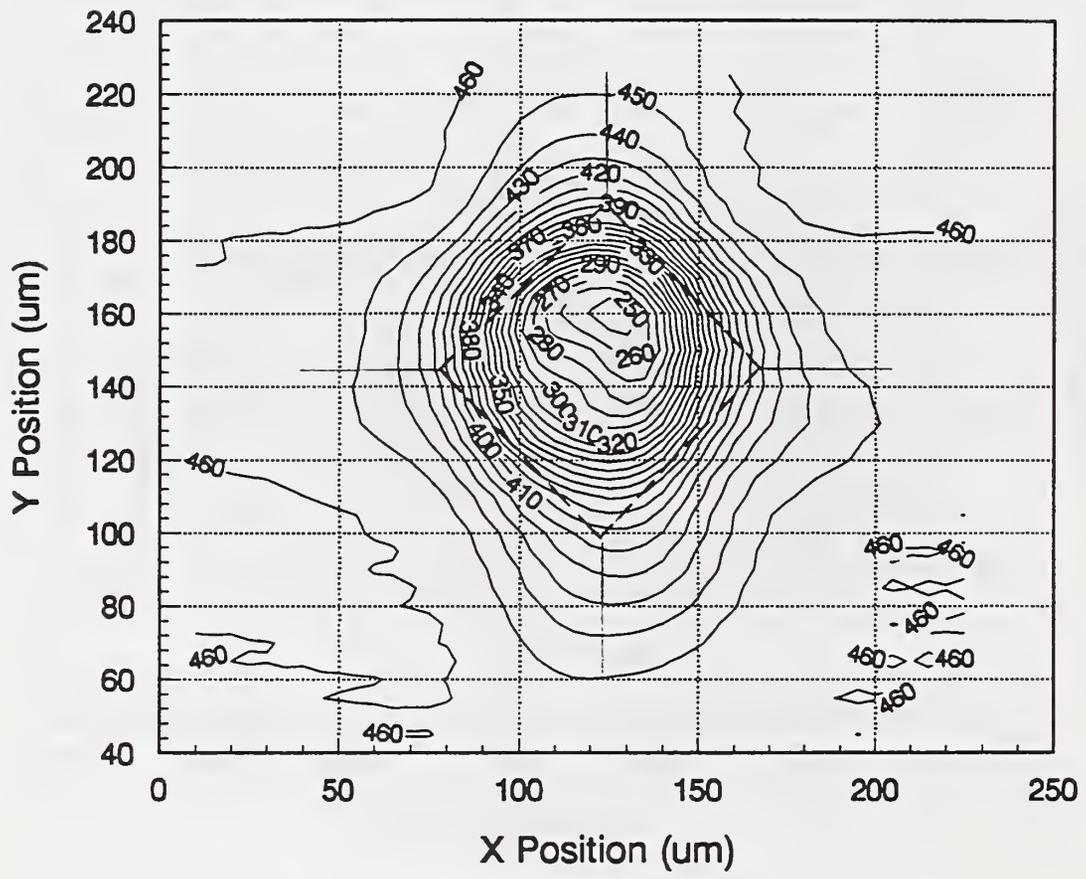
The results for ultrasonic examination of the small indent in silicon nitride are shown in Fig. 6 (a), where the indent shape is superimposed on the contour plot of the echo-amplitude. Dense contours, similar to the results obtained on the glass sample, are observed in the region of the indent. The circular band of amplitude reduction around the indent may be associated with the impression and/or the plastic deformation region beneath and around the indent. The reduction of the echo-amplitude is more clearly represented in the 3-D plot of Fig. 7 (a). The width of the circular band of amplitude reduction surrounding the indent is approximately $15 \sim 20 \mu\text{m}$, which corresponds to the beam width or the lateral resolution of the ultrasonic beam for the 50 MHz transducer used for obtaining the signal. Another measurement with a 150 MHz transducer showed a similar result supporting this observation. Therefore, the circular pattern in the contour plot of Fig. 6 (a) is believed to be associated only with the indent impression, and is not significantly influenced by the plastic deformation region surrounding the indent.

The results of the ultrasonic measurements on the larger indent in the 3-D plot of the echo-amplitude map in Fig. 7 (b) demonstrates a conspicuous region of amplitude drop. The contour plots in Figs. 6 (b) and (c) taken with the 50 MHz and the 100 MHz transducers clearly demonstrate that the contours are not circular, but are distorted. The diamond-marks superimposed on the contour plots delineate the size and shape of the indents and their probable location, as well as the length of the median/radial cracks emanating from the indent corners. There is a close correlation between the location of the median/radial cracks and the distortion of the contours. It is not clear whether this distortion is caused by the vertical cracks or by the lateral cracks below the surface. Since compressional waves are not sensitive to vertical cracks, it can be surmised that the contour shape is either influenced by the lateral cracks or by weak interference effects from the vertical cracks.

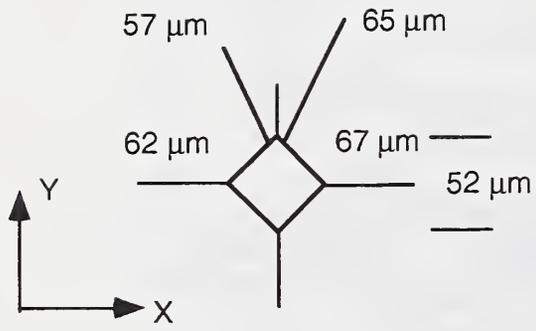
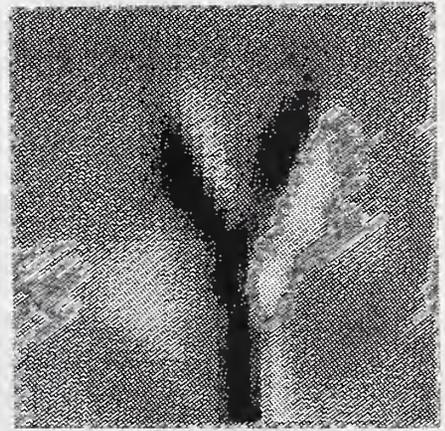
propagation direction and do not disturb the heat flow. The lateral cracks and the indent impression can be only vaguely seen in the background of the thermal wave image in Fig. 10 (a). In order to detect the lateral cracks, the normal deflection component of the probe beam must be used.

The transverse component of the deflected probe beam (parallel to the sample surface) was used for the detection of the median/radial cracks emanating from the corners of the indent in glass. The transverse component is sensitive to the thermal waves with preferential propagation along the surface [Grice et al., 1983] and perpendicular to the vertical crack plane. An image of a raster scan on the glass specimen is shown in Fig. 10 (a), using a step size of $5\ \mu\text{m}$ in both X and Y directions. The scan covers a $200 \times 200\ \mu\text{m}$ area, giving approximately the same scale as the schematic in Fig. 10 (b). The modulation frequency used was $20\ \text{Hz}$, corresponding to the thermal diffusion length of $100\ \mu\text{m}$ in the material. In the image, the darker areas indicate a larger signal, corresponding to higher local temperatures on the specimen. In these high temperature regions, the heat flow is disturbed by the existence of a defect or a crack. The two secondary radial cracks and the median/radial crack in the Y direction can be clearly seen in Fig. 10 (a) as a "Y". However, the other median/radial cracks located along the X direction are not observed, because these cracks are located in a plane parallel to the heat

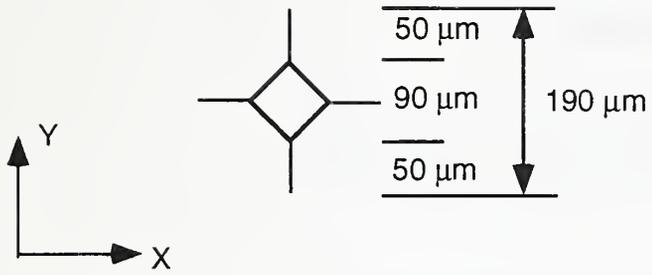
A thermal image of the large indent on the silicon nitride sample, using a step size of $10\ \mu\text{m}$ and the normal component of the deflected probe beam, is shown in Fig.11 (a). The bright spot located in the middle of the image corresponds to the center point of the indent; the surrounding area with different grey scale indicates reflection of the thermal waves from subsurface damage, i.e., the lateral cracks. The vertical cracks are not clearly seen in this image because the normal component of the deflected beam is more sensitive to cracks that are parallel to the surface. Figure 11 (b) is a schematic drawing of the indentation damage on the silicon nitride specimen showing the indent and a well-developed median/radial crack system. Figure 11 (c) is a thermal image using the transverse component of the deflected probe beam, showing only the median/radial cracks that are perpendicular to the scan direction, i.e., parallel to the Y-axis. Similar to the results obtained on the glass sample, the median/radial crack located along the X direction is not detected.

The length of the median/radial crack detected by the thermal wave measurement technique, Fig. 11 (c), is approximately $240\ \mu\text{m}$, which is about 20% larger than the length measured in the optical microscope. This discrepancy, also observed by Rantala et al. [1990], may be related to the crack opening, since tightly closed cracks cannot be observed by optical microscopy. As a confirmation of this point, the signal from the median/radial crack located on the top corner of the indent is shown in the 3-D plot in Fig. 12. The figure indicates that the signal amplitude decreases as the distance from the indent corner is increased. This behavior may be associated with the decrease in the crack opening along the crack.

- Figure 11. (a) Thermal wave image of the large indent on silicon nitride using the normal deflection component of the probe beam, (b) schematic drawing of the indent, and (c) thermal wave image of the same area using the transverse deflection component (the scan area for both images in (a) and (c) is $300 \times 300 \mu\text{m}$).

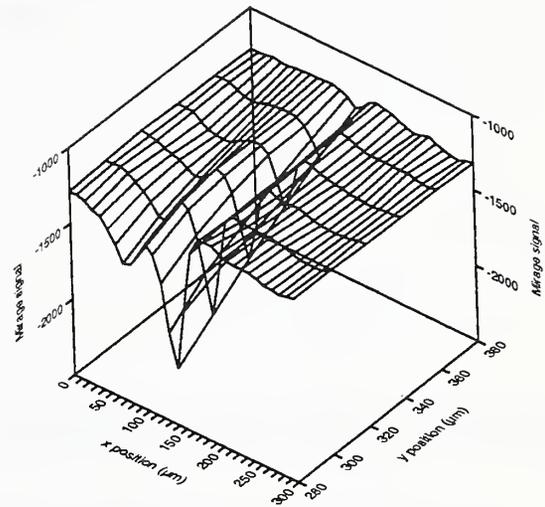
Fig. 12

- Figure 12. 3-D plot of the mirage signal associated with the median/radial crack located in the upper corner of the indent in Fig. 11 (b).

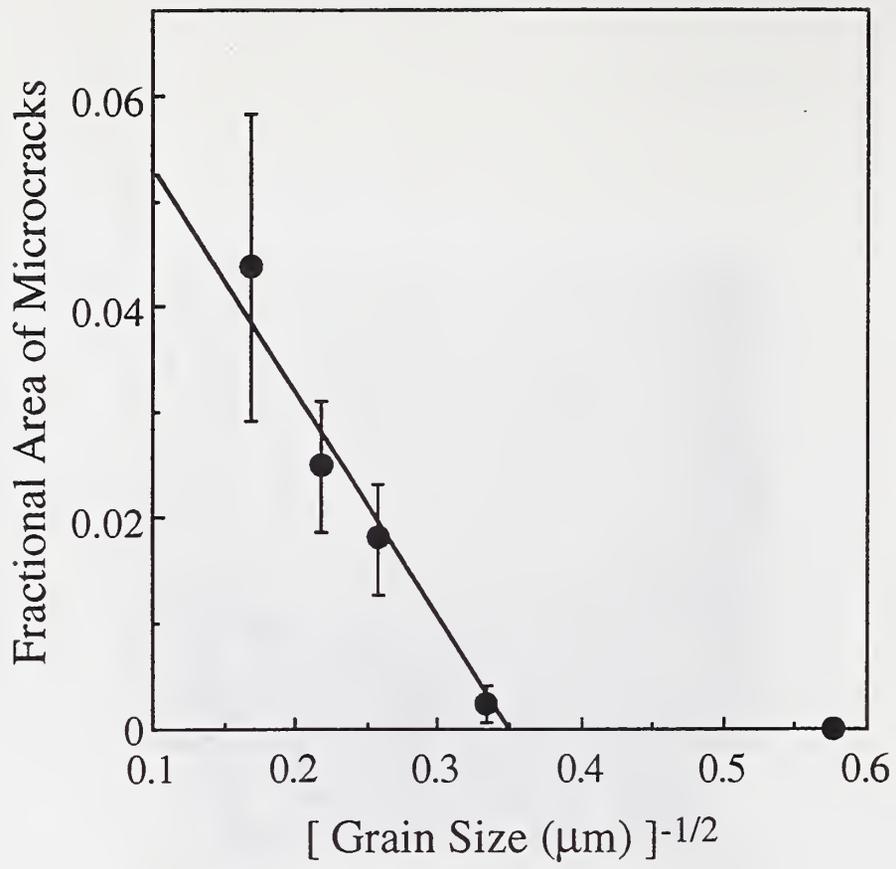
Fig. 12

12. Thermal wave measurement of microcrack density as a function of the square root of the grain size. Each data point is the average of four measurements and the error bars are the standard deviations of the measurements.

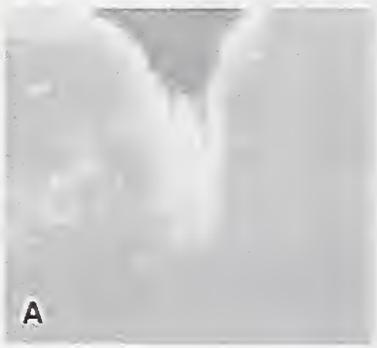
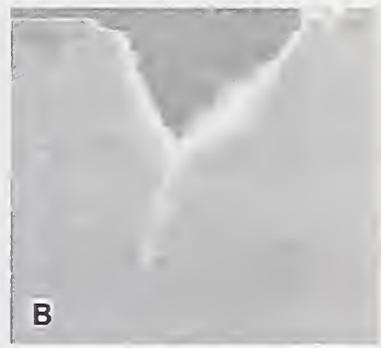
Fig. 5

5. Thermal wave images of the subsurface damage zone in (A) fine-grain and (B) coarse-grain silicon nitride. For the fine-grain silicon nitride in (A), the signal magnitude was small. So the images were so adjusted to best show the features for the fine-grain material. The size of each image is 160 x 170 μm .

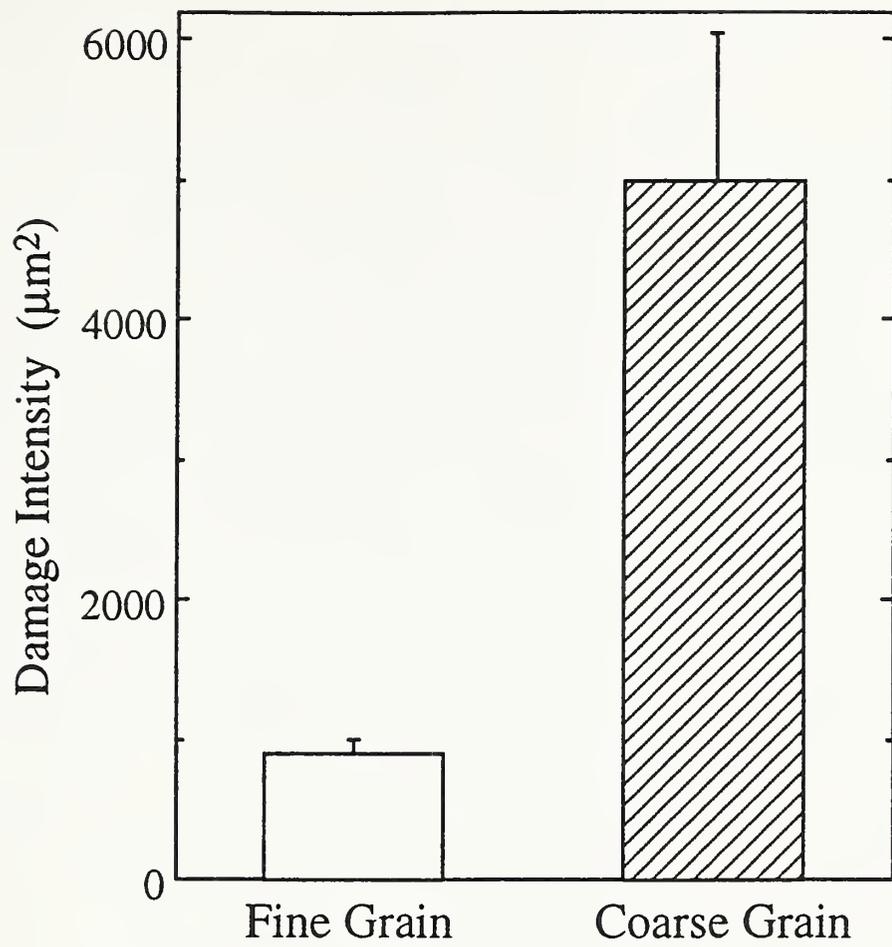
Fig. 6

6. Damage intensity for the fine-grain and coarse-grain silicon nitrides. Error bars show the standard deviations of the three measurements made on each material.
